Aanis Uzair¹, Lars Abrahamczyk¹, Ante Vrban², Davorin Penava²

Seismic Performance Assessment of the 18th Century Jesuit College in Dubrovnik

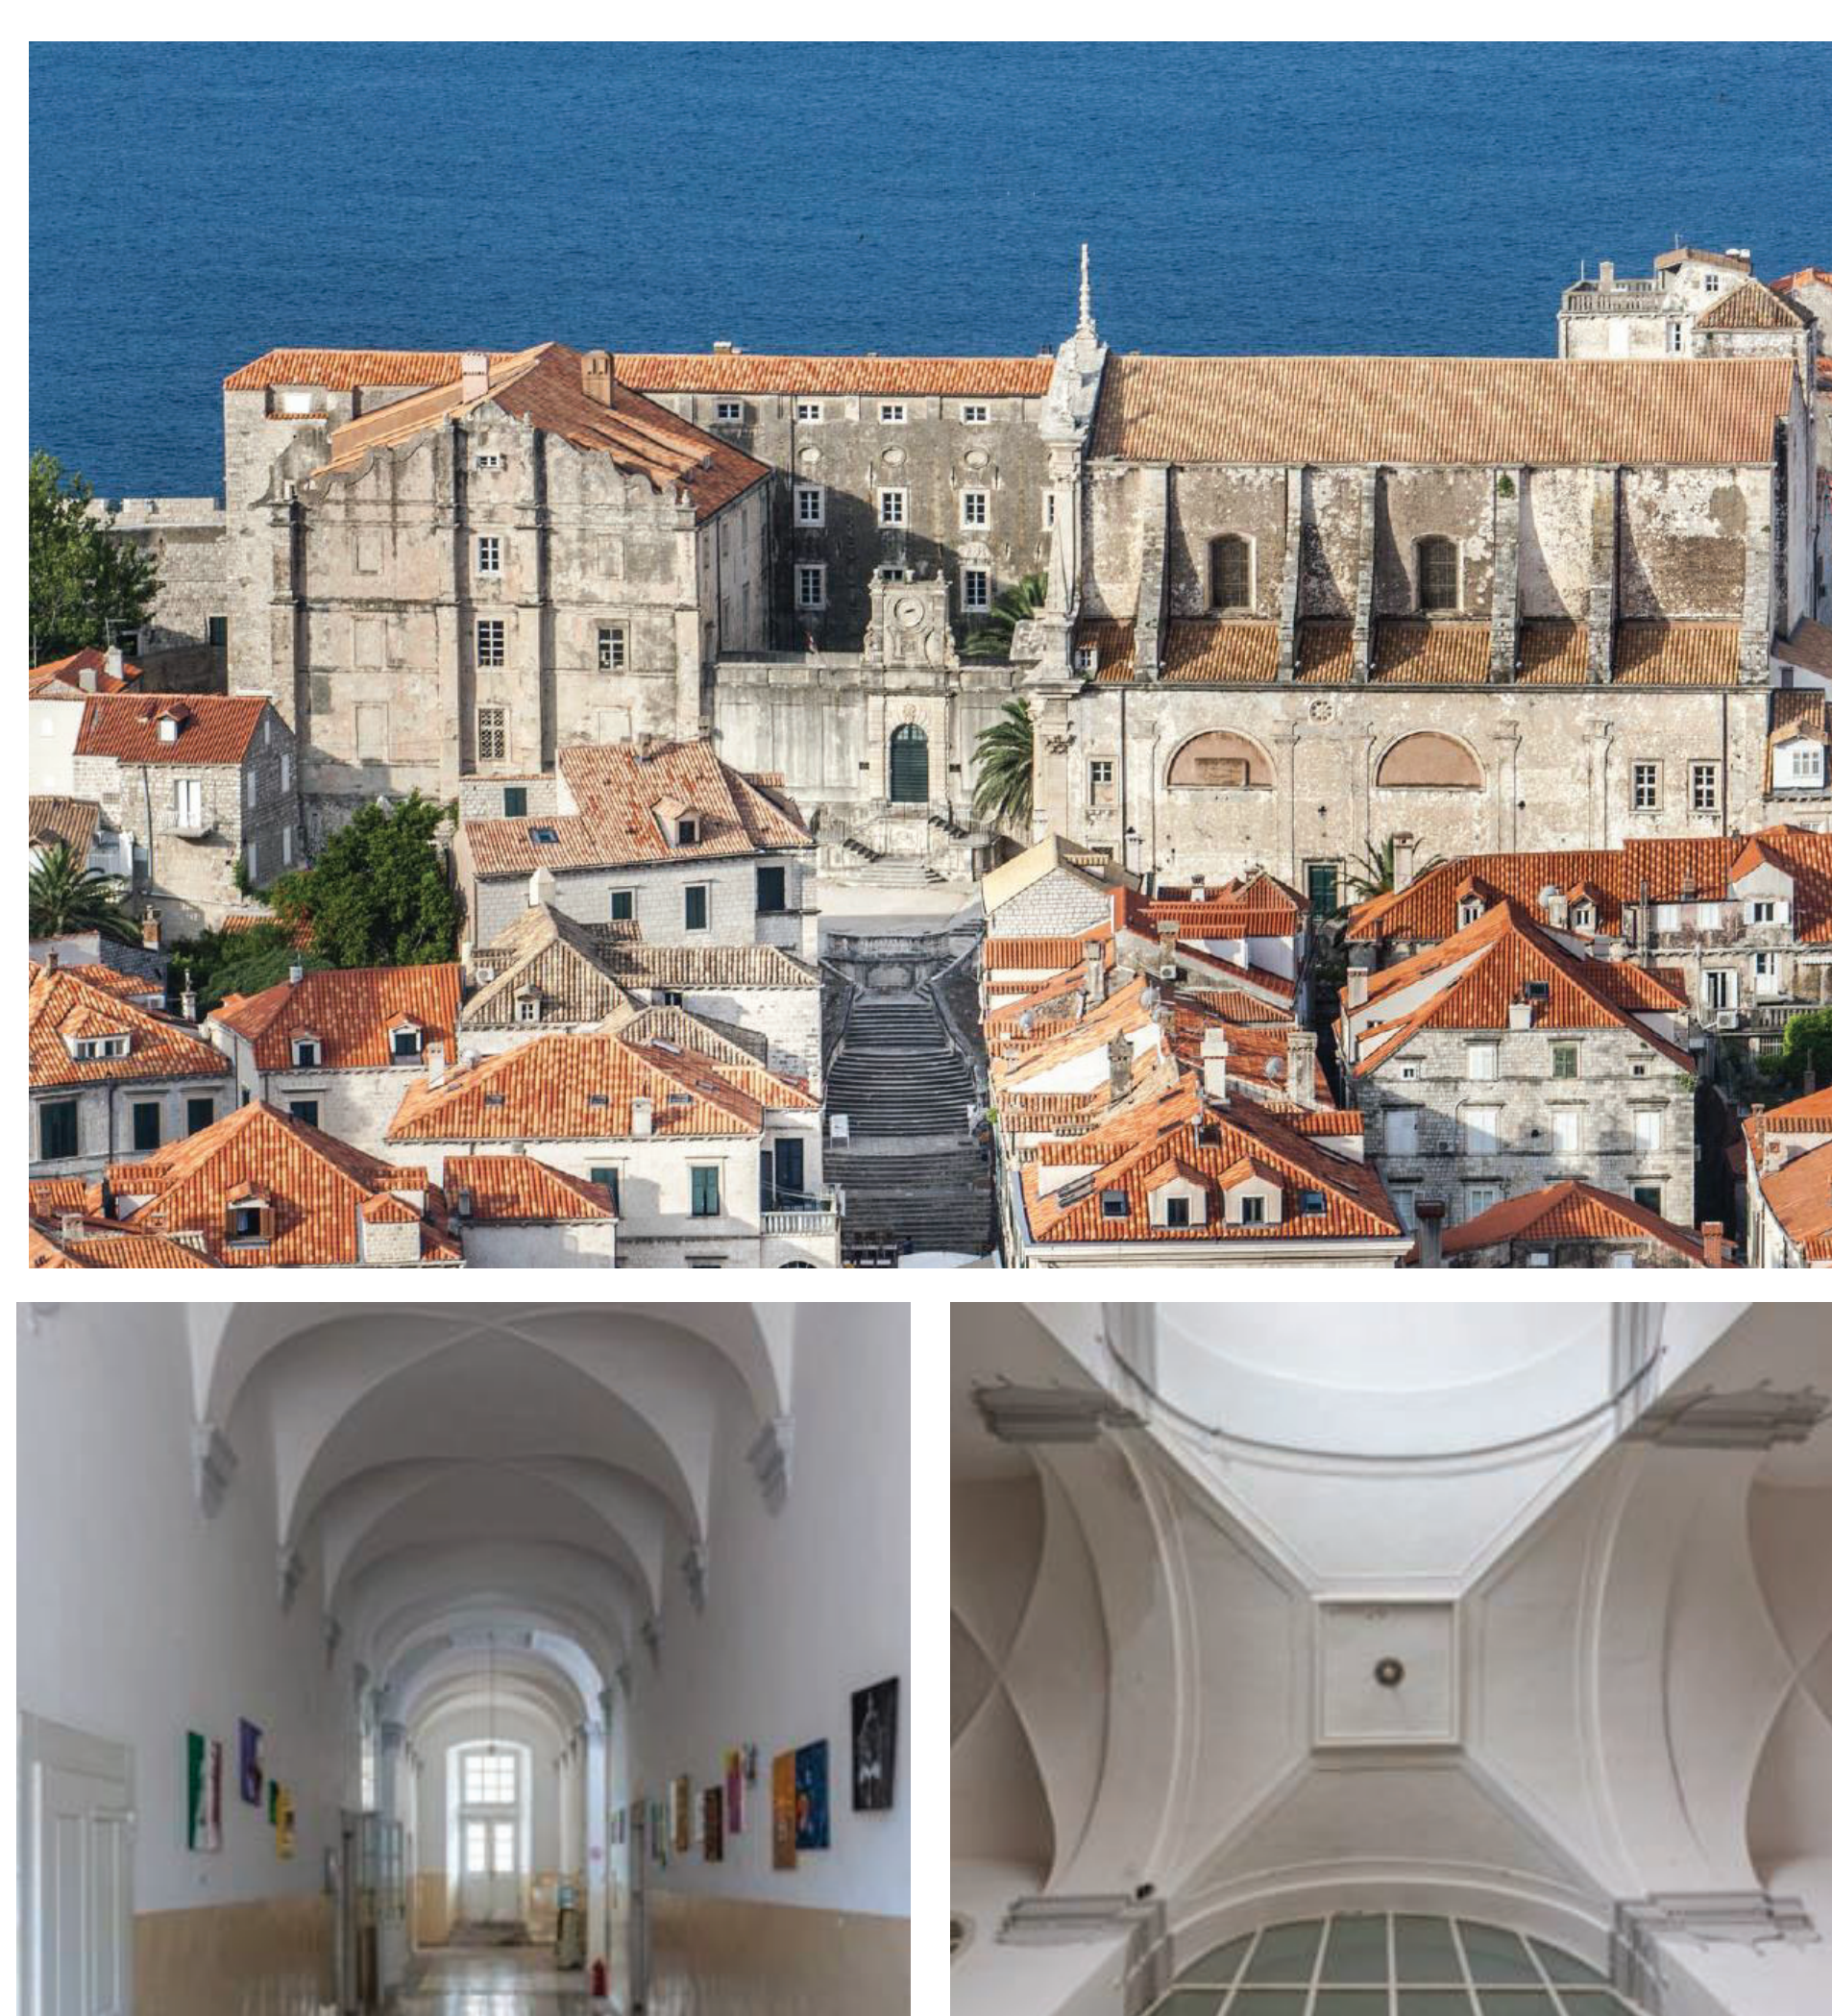
Figure 1. Overview of the geometrical characteristics

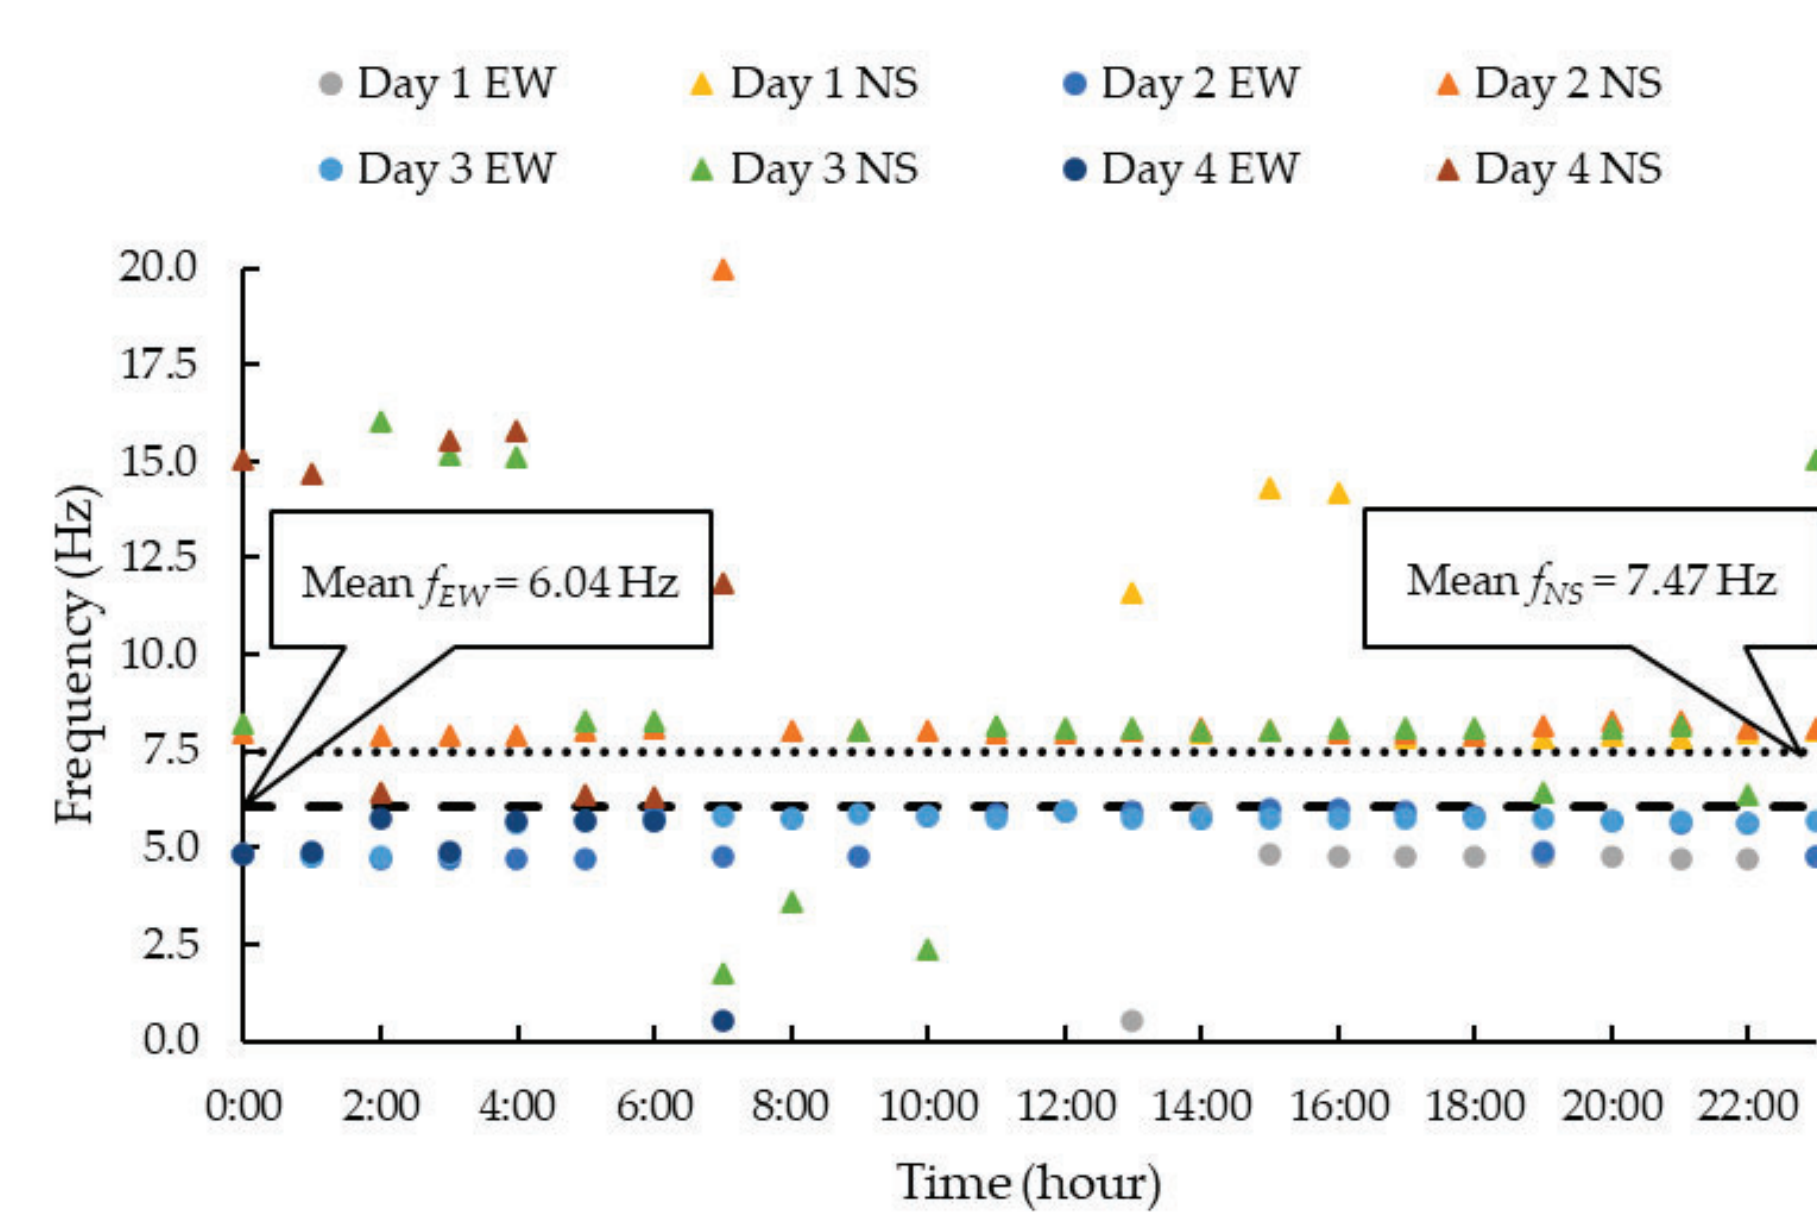
The stiffness of the structure is determined using the vibrational characteristics of the case study building (i.e., natural frequencies), where the geometrical properties are known, and the material characteristics are determined by a trial-and-error process.

Figure 2. Natural frequencies obtained from AVT
