Kirchenburg Walldorf

Experimental Structural Dynamics

Presented by:
Salina Maharjan
David Bonilla

Bauhaus Universität Weimar - 17/07/2020

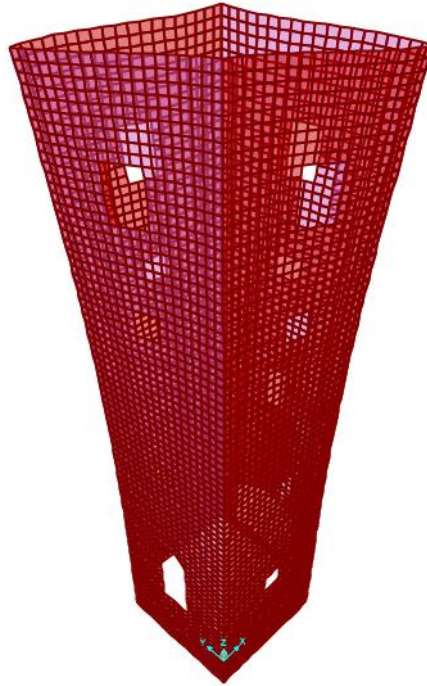
F = 8.04 Hz

Mode	Frequency (Hz)	Shape
1	2.33	1 st Translation X
2	2.41	1 st Translation Y
3	5.86	1 st Torsion
4	7.13	2 nd Translation Y
5	8.04	Walls in-out of plane
6	8.91	2 nd Translation X
